MUEngineers, Inc.

Reference	Project Name:	Bora Bora Bldg-Mai Kai-Structural Assessment
	Project Address:	Fort Lauderdale, Florida
	MUE PN:	MUE22061303

Exhibit A – Photographs

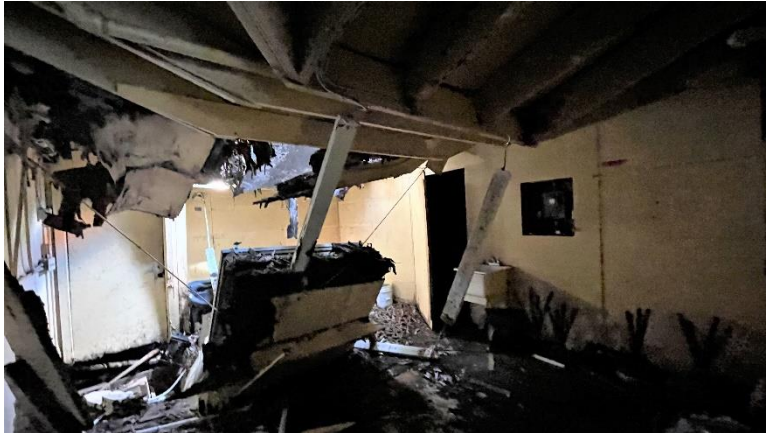
Photo 001:

Collapsed roof framing section

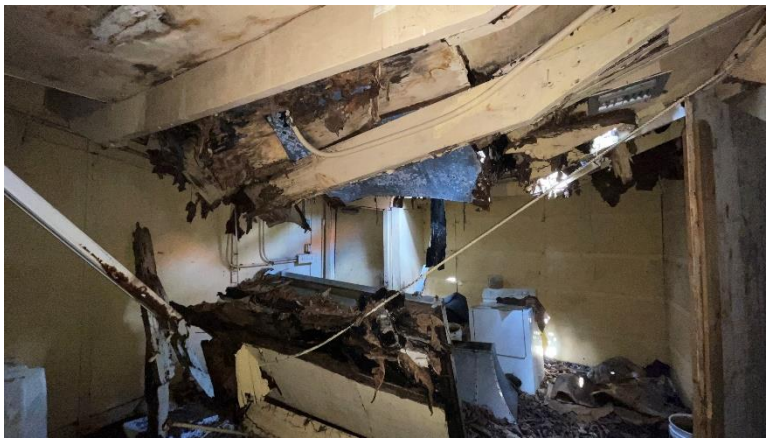
Photo 002:

Collapsed roof framing section

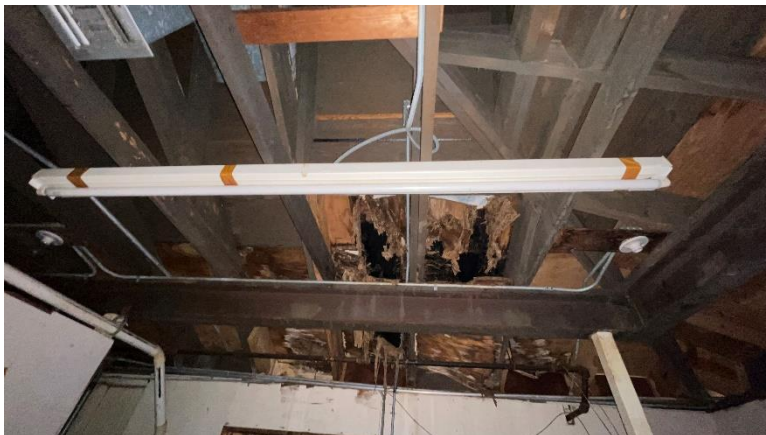
Photo 003:

Partially collapsed wood roof sheathing and wood roof framing

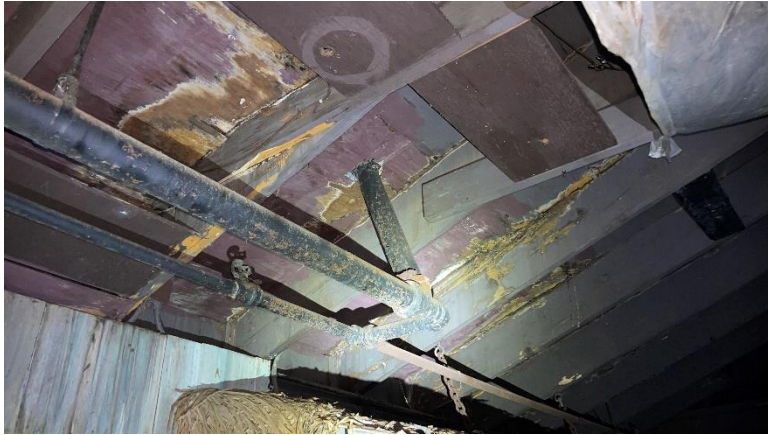
Photo 004:

Decayed roof sheathing and roof framing

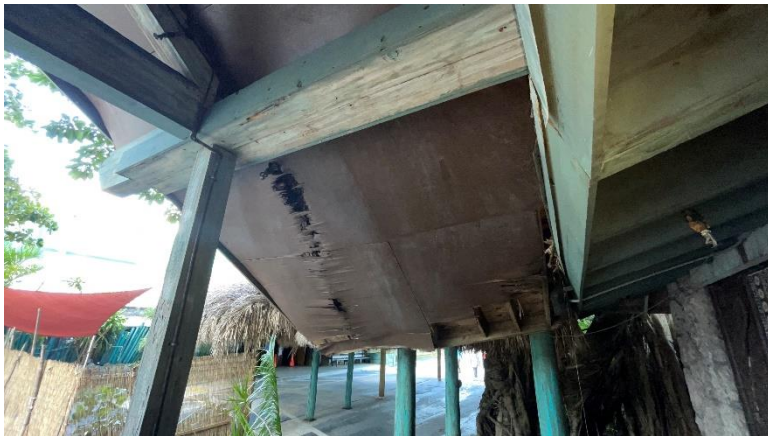
Photo 005:

Decayed exterior roof framing and soffit sheathing

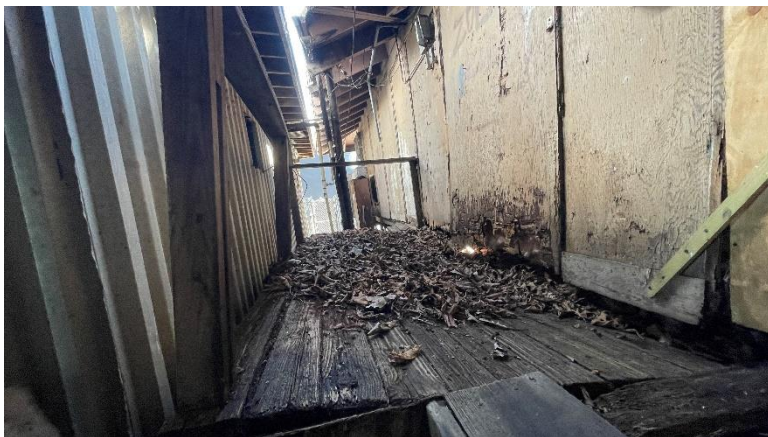
Photo 006:

Decayed exterior wood wall and floor framing

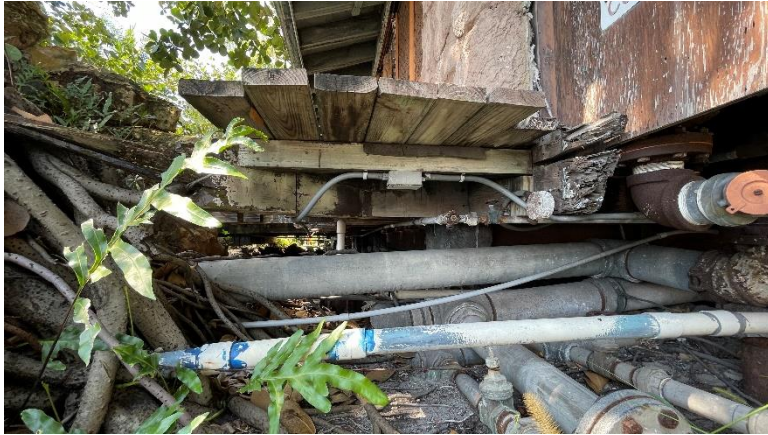
Photo 007:

Decayed exterior wood deck and wall framing

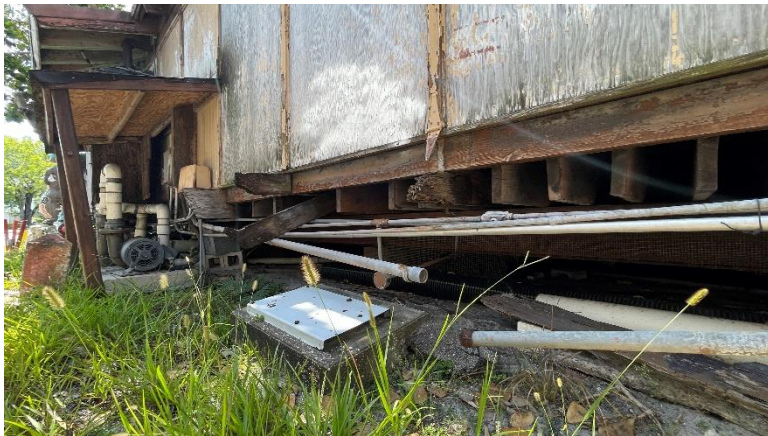
Photo 008:

Decayed wood wall and floor framing

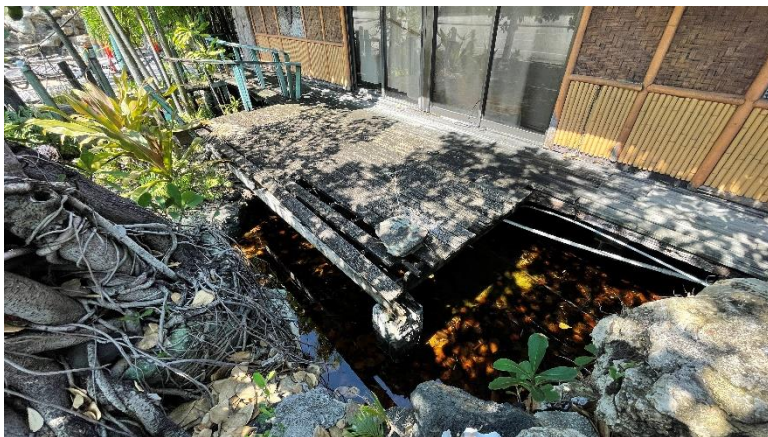
Photo 009:

Decayed exterior wood deck
