## PRESERVATION BRIEFS

# 30

## The Preservation and Repair of Historic Clay Tile Roofs

Anne E. Grimmer and Paul K. Williams

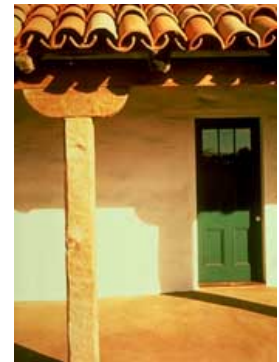
Tapered barrel clay roof tiles were custom made for the restoration of the 1820s Indian barracks at Mission Santa Cruz in California. Photo: NPS files.

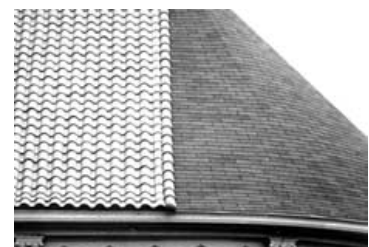
Asphalt shingles are an incompatible replacement substitute for the original Spanish clay tiles. Photo: NPS files.

The most important repair to avoid is replacing broken or missing roof tiles on a historic building with materials other than matching natural clay tiles. Concrete, metal or plastic tiles are generally not appropriate substitutes for clay roofing tiles. They lack the natural color variations of clay tile, and they do not have the same texture, shape, thickness or surface irregularities.

Although much concrete tile and composition tile is produced to resemble the general shape, if not the exact profile, of clay roofing tiles, concrete tile is generally too thick and also lacks the range of colors inherent in natural clay tile. Concrete tile is not a compatible substitute material to repair or replace individual historic clay tiles.

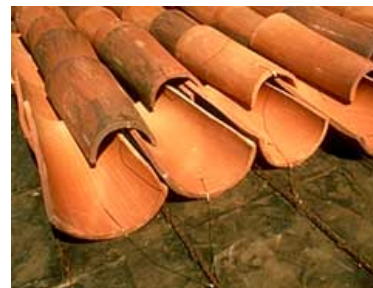
A special system consisting of brass or copper wires is used to attach these tapered barrel roof tiles. Photo: NPS files.

With Mission or Barrel tiles, where one half-cylinder overlaps another inverted half-cylinder to form a cover and pan (cap and trough) arrangement, the fastening is more complicated. While the pantiles that rest directly on the sheathing are simply nailed in place, there are two ways of attaching the cover tiles that rest on the pantiles. They can be secured by a copper wire nailed to the sheathing or tied to vertical copper strips running behind the tiles. Another method requires the installation of vertical battens or nailing strips on the roof to which the cover tiles are nailed, or the use of tile nails or hooks, which are hooked to the pantile below and secured with twisted copper wire.
