Date: December 16, 2022  
To: **City of Oakland Park** Development Review Committee & Historic Board  
From: **Melissa Ann Bierman**, Kravit Architectural Associates  
CC: File JBC.25  
Re: Mai Kai Restaurant and Polynesian Show 3599 N Federal Highway Oakland Park, FL  
Certificate of Appropriateness Letter of Intent

We would like to request a Certificate of Appropriateness for the proposed exterior renovations to the Mai Kai Restaurant located at 3599 N Federal Highway Oakland Park, FL.

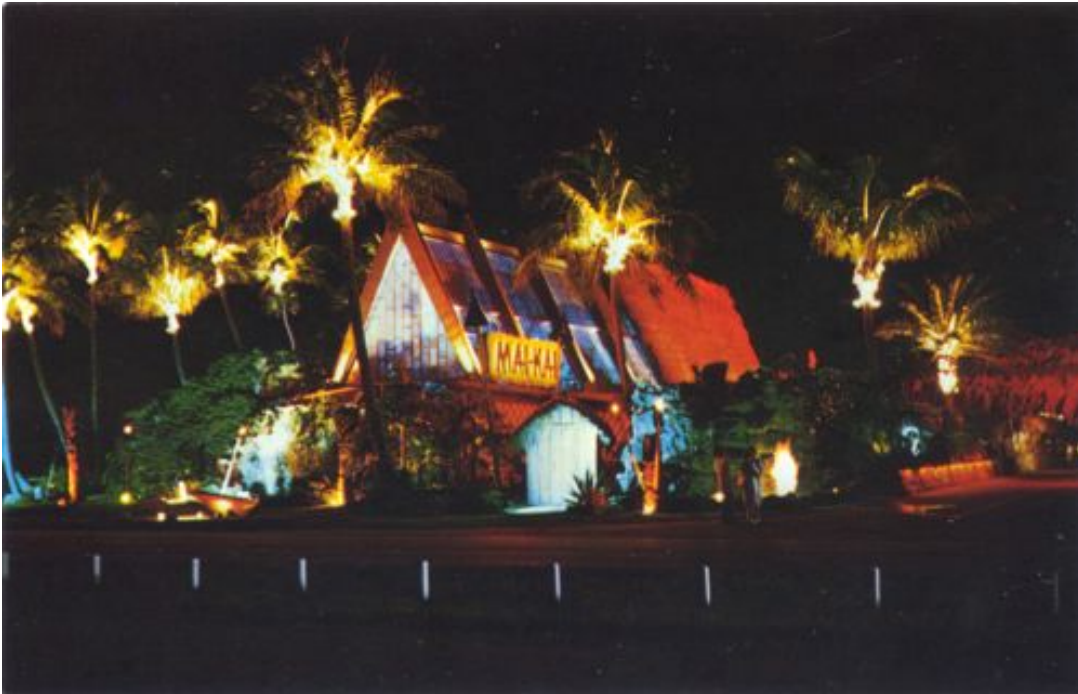
Reference Image 1 – Historic Photo with Palm Thatching

North Elevation - Height of the vertical wood planks to match existing are to be raised and replaced in kind to match existing finish and color. Previously removed thatched mansard roof to be reinstalled at previous location with new palm thatching. Thatching of Porte cochere to be replaced. Palm thatching to be partially reinstalled over main A-frame per original photographs. Repaint existing main A-frame with colors to match existing.

*Architect's Response: Complies, we are replacing the missing palm thatching on the main A-frame roof. The intent is to repair elements, when possible, or to replace in kind to match the existing. The original wood tikis have been replaced over time with fiberglass, due to the exposure from the elements. Molds of the original tikis were made in the intent is to use the molds to replace the missing or damaged tikis.*

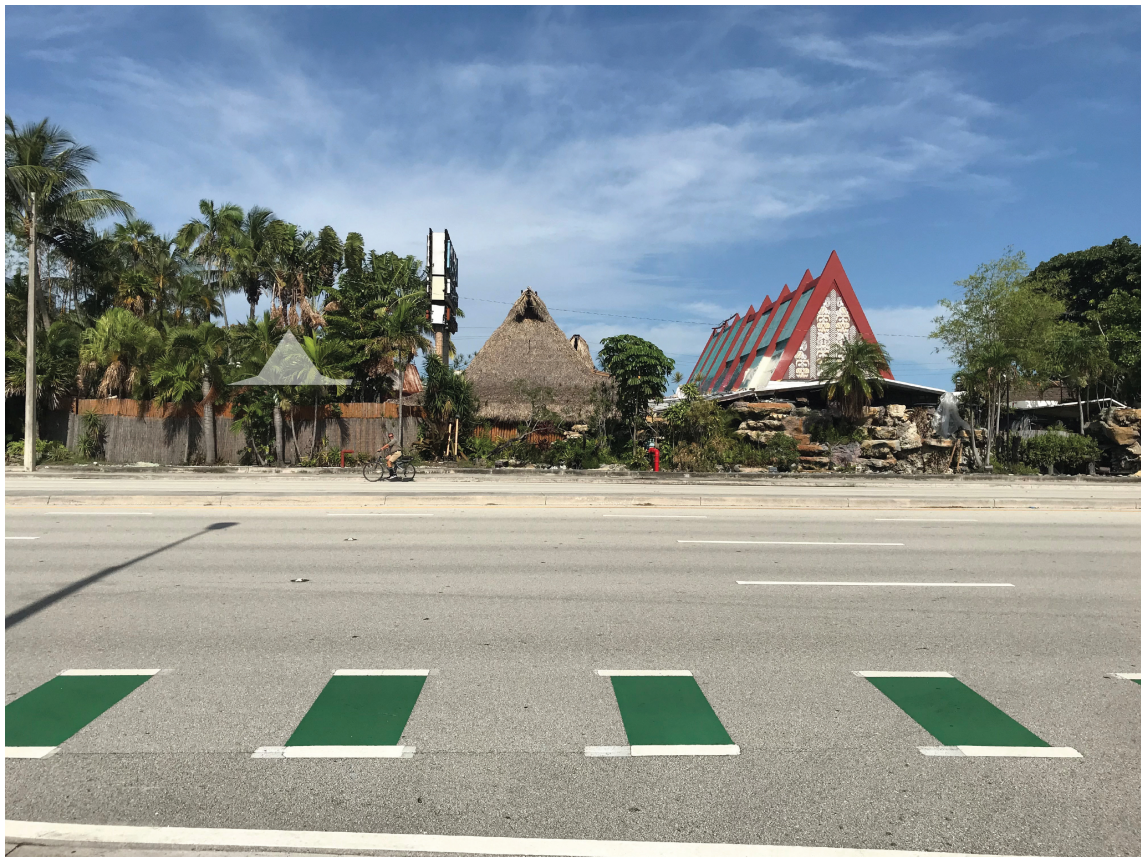
Reference Image 2 – Street View from Federal with new roof outline beyond  
(not visible from street)
